ҚАЗАҚСТАН ҒЫЛЫМЫ МЕН ТЕХНИКАСЫ

*P. Gavrilovs¹, V. Ivanovs², D. Gorbacovs³

^{1,2,3}Riga Technical University, Latvia, Riga

STUDY OF DAMAGE TO VAE CROSS CROSSING

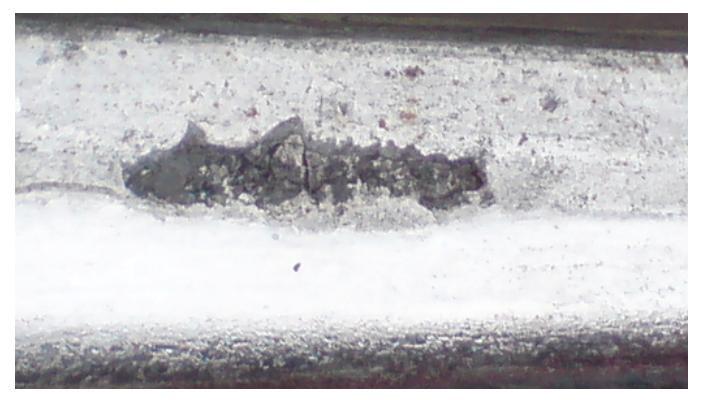
In most cases, following the gross passage of 20–40 million tonnes for the new VAE crossings in the wheel crossing area from the wing rail to the core, in the harmful

expanse, there are shallow and deep shortages (Figure 3). When the wheel shifts these unevenings result in the dynamic forces of the impact leading to calamation, detachment and cracks in a highly alloy manganese layer [4].

Figure 3 - Core fissures of VAE cross 60E1 1/11

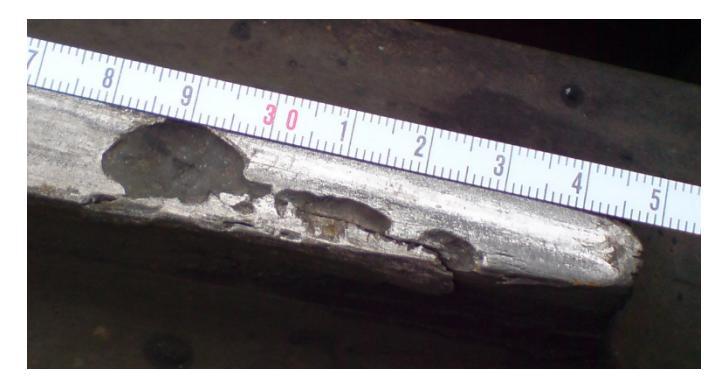
Longitudinal cracks and fractures for VAE crossings on Latvian railways [12] are most commonly observed on the main roads (Figure 4) at loadload of more than 30 million tonnes gross per year.

Figure 4 – Breaking of the core of the VAE cross 60E1 1/11 and cracks at the Alotene station

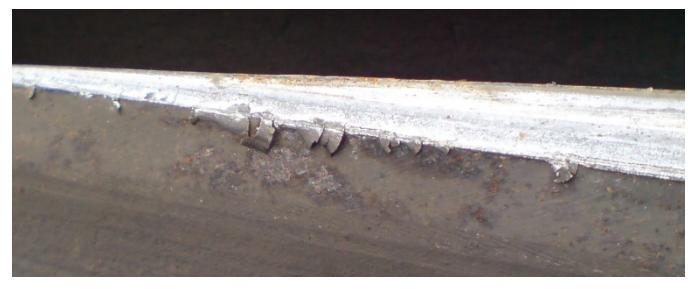
In Latvian railways, it is not always timely that floodings are drowned, resulting in scarves (Figure 5), later breaking them down and the roughness begins to spread throughout the size of the core. From the vibrations caused by unevenings, the crucifixion gradually collapses and becomes unusable.

Figure 5 - VAE cross-over R-65 1/11 core burst at the yard station

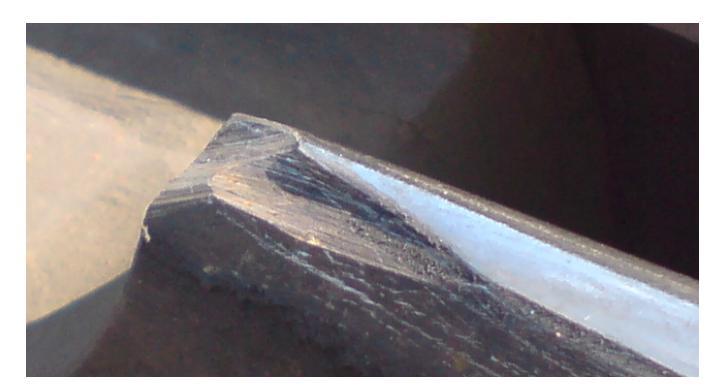
In addition to insufficient maintenance: too wide anti-rail trays, worn counter rails and narrowed road widths, the rim of the wheel may remove the end of the core (Figure 6).

Figure 6 – Breakage of the end of the core of VAE cross R-65 1/9 at the Skirotavas station

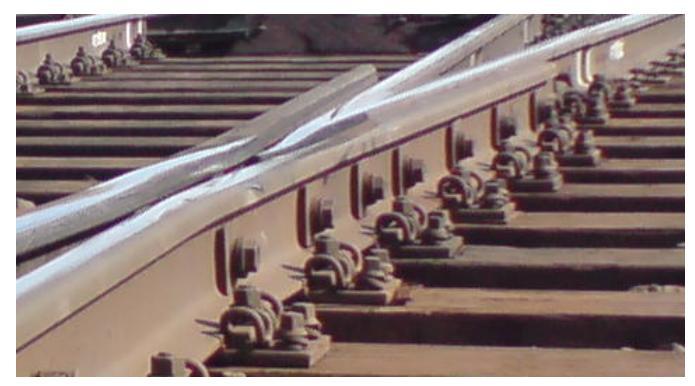
By releasing approximately 115 million tonnes of gross cargo and independently operating THE VAE cross, a worn crucifixion sedli (Figure 7), visible as a hole from a distance of 15 m, occurs on the core and on the wing.

Figure 7 – VAE cross R-65 1/11 worn core at the Aizkraukle station

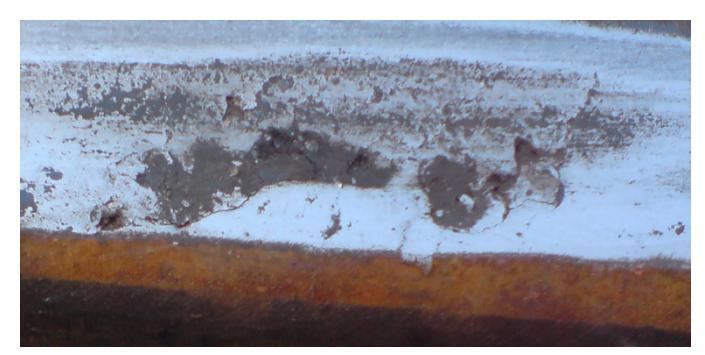
Similarly, as the pelling, detachment and cracking of VAE cores (Figure 3) is common, the rolling surface of the winging rails is also damaged (Figure 8). The characteristic zone of the defect is the harmful expanse.

Figure 8 - VAE cross 60E1 1/11 cracks at Slampes station

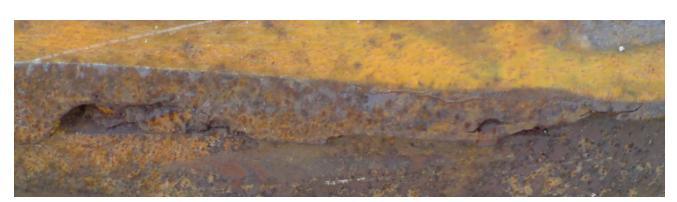
Rebuilding the wing threshold in melting is not always as successful as it was originally expected. Non-welding causes deep and long longitudinal detachment cracks (Figure 9).

Figure 9 - VAE cross-cross R-65 1/11 detachment at Slampes station

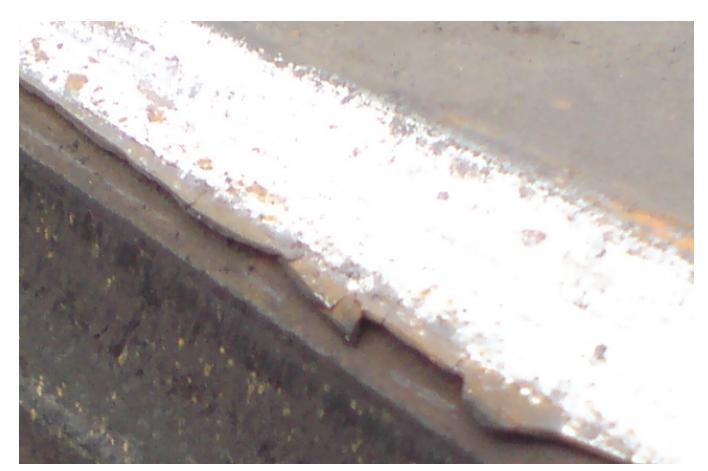
Similarly to the lack of timely tapping of cores, there is no timely polishing of the winging rails for how connected these operations are. Similar problems arise with splinters (Figure 10).

Figure 10 - VAE cross R-65 1/11 at the Skirotavas station

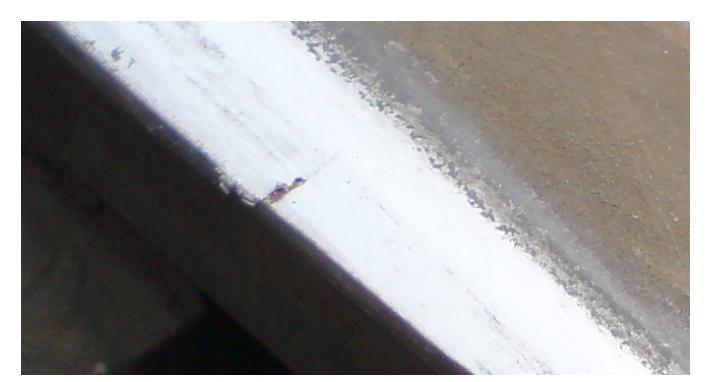
Crossroads often form at the beginning of the harmful cracks (Figure 11).

Figure 11 – VAE cross, R-65 1/11 cross-slide, Aizkraukle station

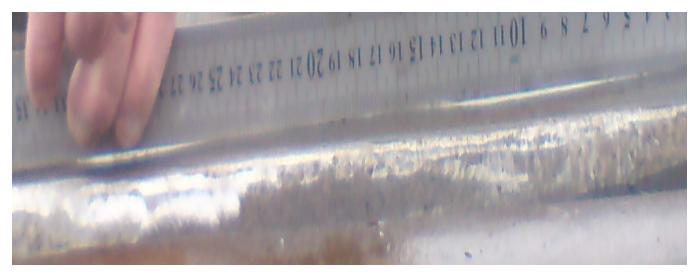
Investigations of VAE cross core melting field conditions at Garozas station. 23.11.2021. the core of the VAE cross was fused with a vertical wear of 6 mm. At the crust station, switch no. During the melting of 3 cores, some deviations from the work technology were found, namely, the core temperature was not monitored often enough by the thermometer by a manual touch welder, and the applied welding current could be in a wide range, inaccurately related to the electrode diameter. any remaining moisture was not dried with the burner.

After melting 25.11.2021. irregularities with hollow recesses formed at the depth of 0.8 mm (Figure 13) on the surface of the core, which was reported to the road master.

Figure 13 – VAE cross 60E1 1/11 core recesses at the Carozas station

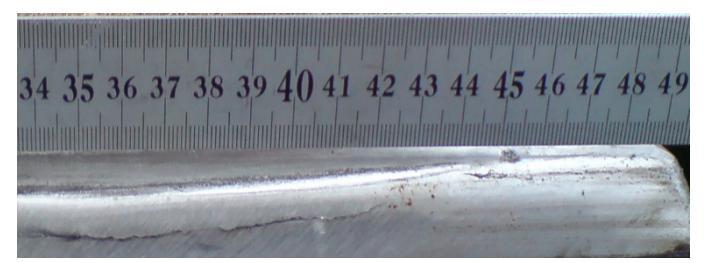
One month after melting, longitudinal cracks appeared in the core [11] and defectoscopists determined that the defect had become dangerous, so 27.12.2021. melting was repeated, this time drying any residual moisture after paint defectoscopy and strictly observing the temperature regime during welding. However, in the first days after melting, non-weld inclusions 2 mm in diameter were discovered, leading to a longitudinal crack of about 90 mm (Figure 14).

Figure 14 – VAE cross 60E1 1/11 core longitudinal crack at Carozas station

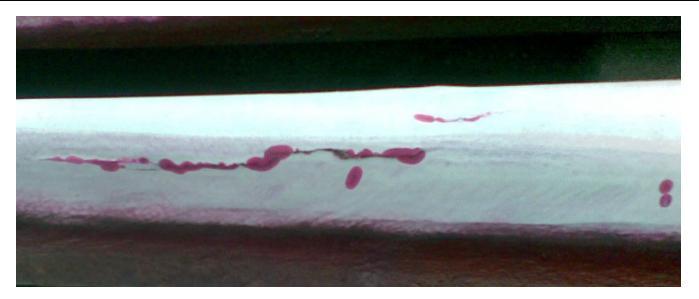
The operation department decided to melt the VAE core for the third time – 23.02.2022. VAE cross cores 08.03.2022. showed long and small cracks during color defectoscopy (Figure 15). Spider was replaced as planned.

Figure 15 – VAE cross 60E1 1/11 core longitudinal crack at Crust station
