ҚАЗАҚСТАН ҒЫЛЫМЫ МЕН ТЕХНИКАСЫ

*P. Gavrilovs¹, V. Ivanovs², D. Gorbacovs³

^{1,2,3}Riga Technical University, Latvia, Riga

STUDY OF DAMAGE TO VAE CROSS CROSSING

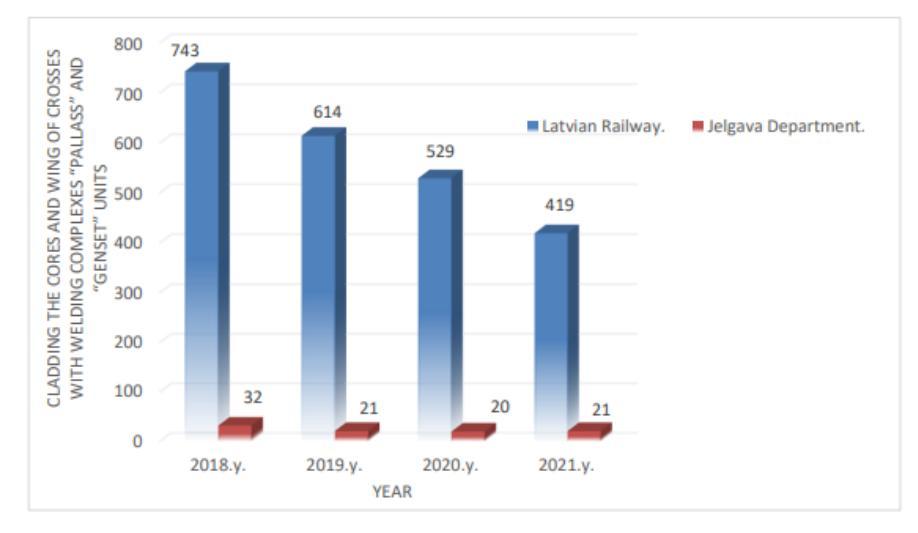
Figure 12 – Statistics of melting of the cross core and wing rail for the period from 2018 to 2021

On Figure 12 we can see how the melting statistics is gradually starting to decrease from 743 melted crosses in 2018 to 419 molten crosses in 2021. Track management for the structure. Jelgava operation parts are one of the number of crossings for the Latvian railway and damaged crossings. According to the smelting statistics (Figure 12), the average smelting statistics for the last three years from 2019 to 2021 in Jelgava consisted of the repair of 20 damaged crossings with welding complexes «PALLAS» and «GENSET», although in 2018 32 damaged crosses were melted. However, smelting technology remains one of the current methods of extending the service life of the cross in Latvia and abroad.
